RE: ACT/049/001, Keigley Quarry, USX

On May 11, 1987, the minerals team reviewed the Keigley Quarry with Thon Gin and Roy Benson of USX to help on the permitting of the quarry. A follow-up letter with a recommended seed mixture, etc., was sent to them on June 1, 1987.

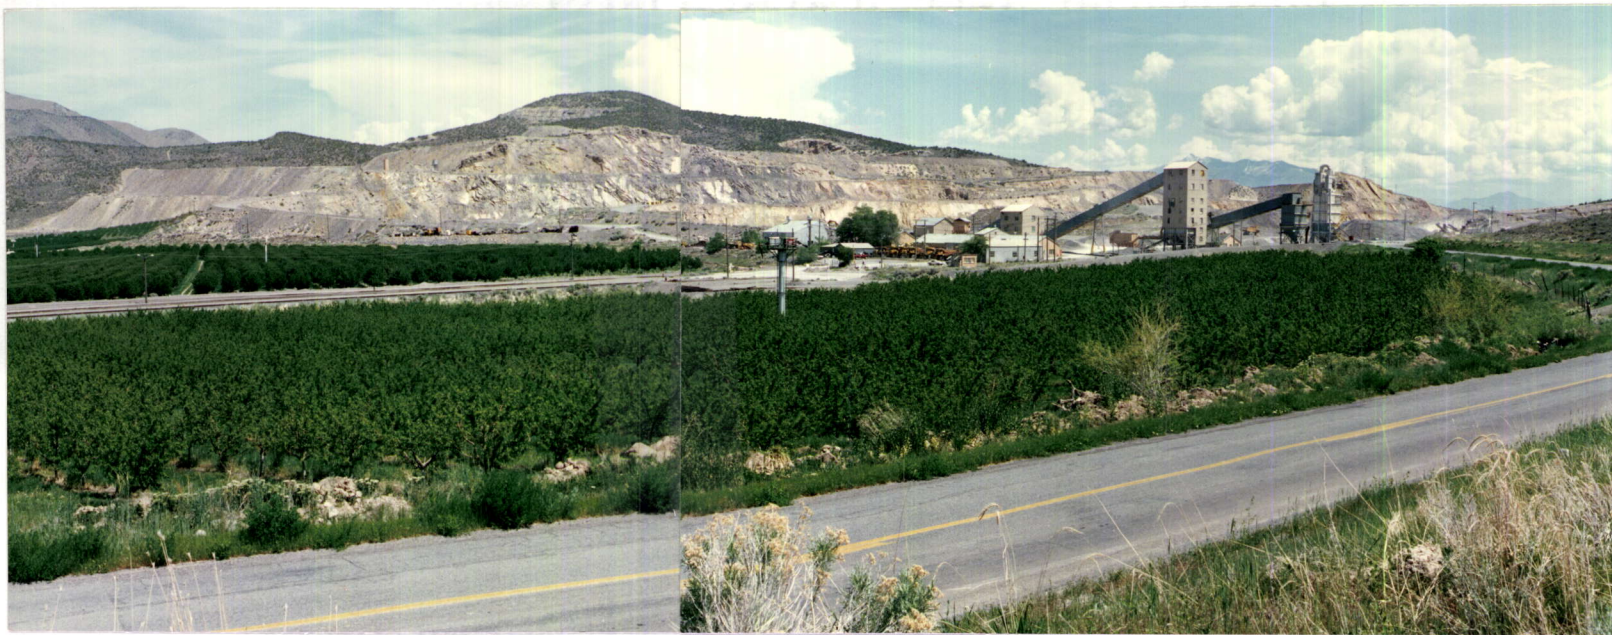
Keigley Quarry, May 11, 1987  
Note the orchards adjoining the quarry.

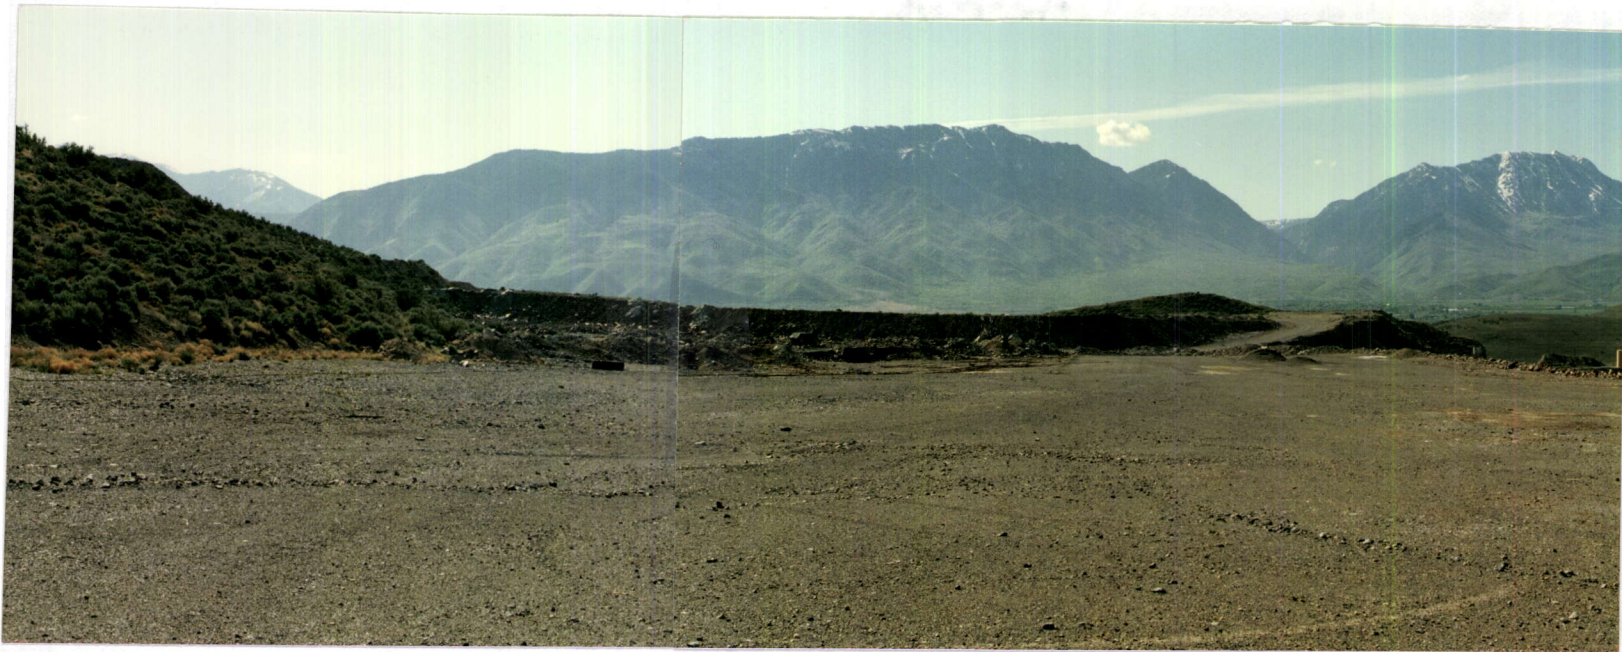
Keigley Quarry Waste Pile Area, May 11, 1987

The hillside (left of photo) bordering the waste pile has a very good native vegetative cover, including bluebunch wheatgrass, cliffrose, big sagebrush, and rabbitbrush. Vegetation ground cover is approximately 20 percent.

This waste pile area will also need to have topsoil material put on it and properly reseeded to meet revegetation requirements.

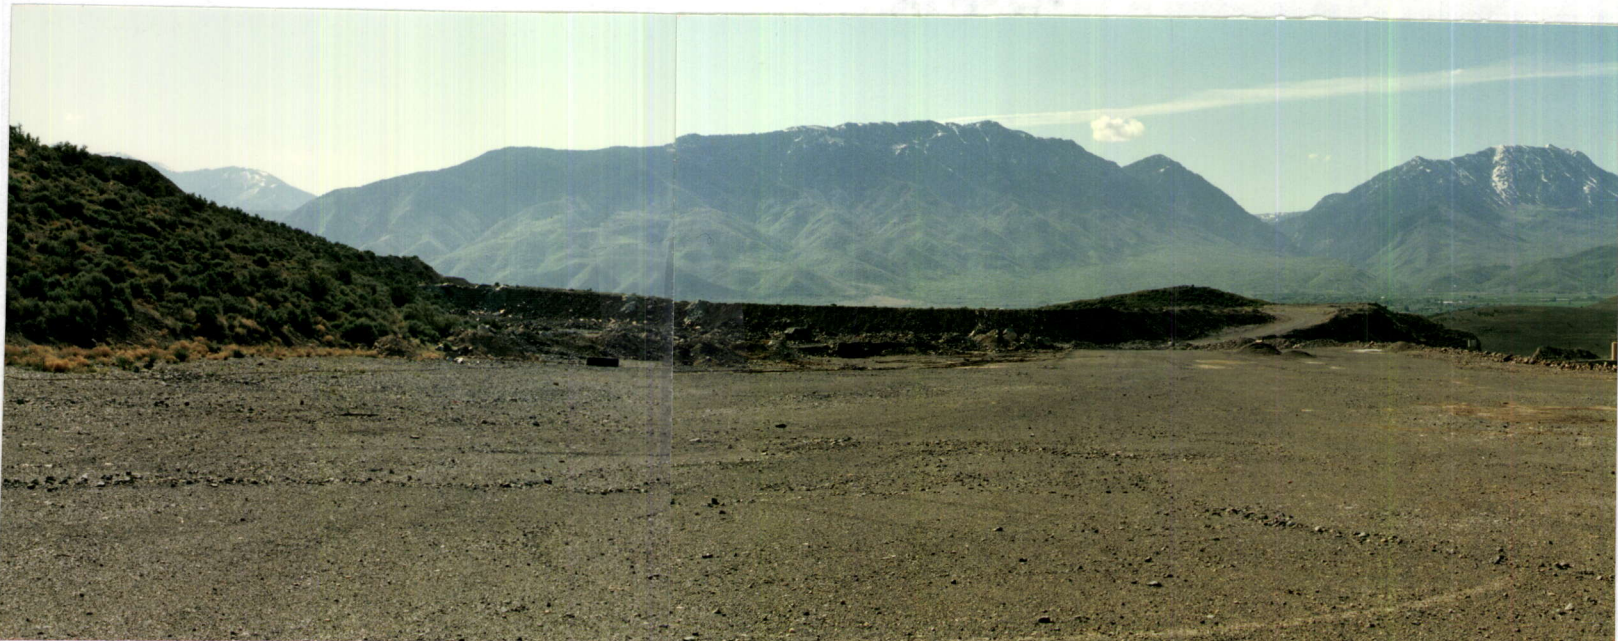
Keigley Quarry Waste Pile Area, May 11, 1987

The hillside (left of photo) bordering the waste pile has a very good native vegetative cover, including bluebunch wheatgrass, cliffrose, big sagebrush, and rabbitbrush. Vegetation ground cover is approximately 20 percent.

This waste pile area will also need to have topsoil material put on it and properly reseeded to meet revegetation requirements.
